**RESOLUTION 21 - 19. 2021**  
**COLUMBIA TOWNSHIP, HAMILTON COUNTY, OHIO**

**AUTHORIZING THE ADMINISTRATOR TO ENTER INTO AN AGREEMENT WITH THE HAMILTON COUNTY ENGINEER TO IMPROVE THE PLAINVILLE RD. PEDESTRIAN CROSSWALK AT GRACE AVE. WITH FLASHING SAFETY LIGHTS AND ENHANCED STRIPING AND SIGNAGE, DISPENSING WITH THE SECOND READING, AND DECLARING AN EMERGENCY**

**JOINT AGREEMENT BETWEEN HAMILTON COUNTY AND COLUMBIA TOWNSHIP  
FOR THE INSTALLATION OF A FLASHING PEDESTRIAN SIGNAL  
ON PLAINVILLE ROAD AT GRACE AVENUE**

**DATE:** 1/15/21  
**SUBJECT:** Plainville Road Crosswalk  
**PREPARED BY:** TEC Engineering, Inc.  
**PREPARED FOR:** Columbia Township

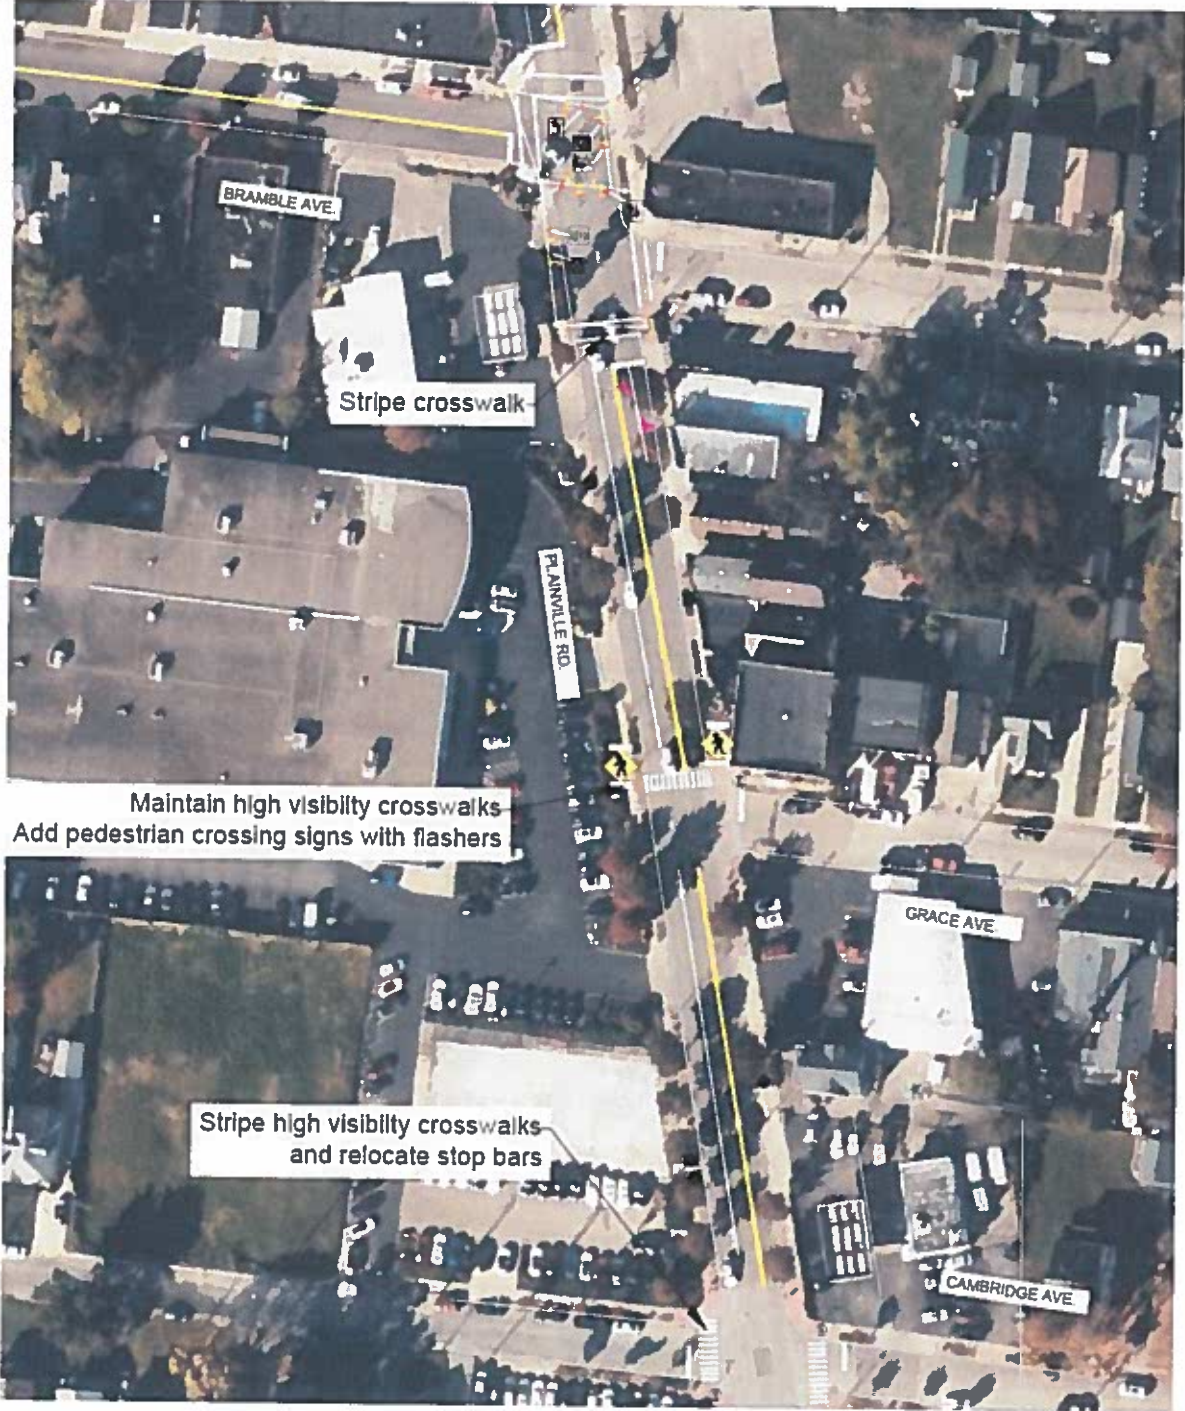
**FIGURE 1: RECOMMENDATIONS**

TEC recommends providing an RRFB at the Grace Avenue location (North leg Crossing). In addition, the high visibility crosswalk should be restriped (even though it is at the crest of a hill). The crest on the roadway at this location actually creates a prioritized crossing for pedestrians and makes them more visible for northbound and southbound drivers.

At Bramble, TEC recommends striping a crosswalk for the south crossing to match the existing crosswalks at the intersection.

At Cambridge, TEC recommends striping high visibility crosswalks for the east and west legs of the intersection. Signage may also be added to prohibit crossing Plainville and directing pedestrians to the Grace Ave crossing. All of these improvements will prepare drivers for pedestrians within this area.

TEC also reviewed pedestrian volumes at the two adjacent intersections to look at overall pedestrian crossing demand along the corridor. At Plainville and Bramble, which is a signalized intersection there were 50 pedestrians crossing during the peak. There are pedestrian signals for crossing Plainville on the north and south sides. However, there are no crosswalk markings on the south crossing. A crosswalk should be added to this crossing. This intersection is maintained by the City of Cincinnati.

At Plainville and Cambridge there were 25 pedestrians crossing Plainville during the PM Peak. There are no marked crossings though there are curb ramps on the corners. While these curb ramps are not designed for crossing Plainville, the lack of crosswalks makes this ambiguous. Given the number of

pedestrians crossing there throughout the PM Peak, signage and markings should be added for the crossings across Cambridge. The intersection of Plainville and Murray is just to the south of the study area. This is an unconventional intersection. Field observation show some driver confusion at this intersection which makes visibility and clear striping and signing even more important as drivers are coming out of a confusing area. Prioritizing this intersection as the primary crossing location may be problematic due to the unconventional nature of the intersection immediately to the south.

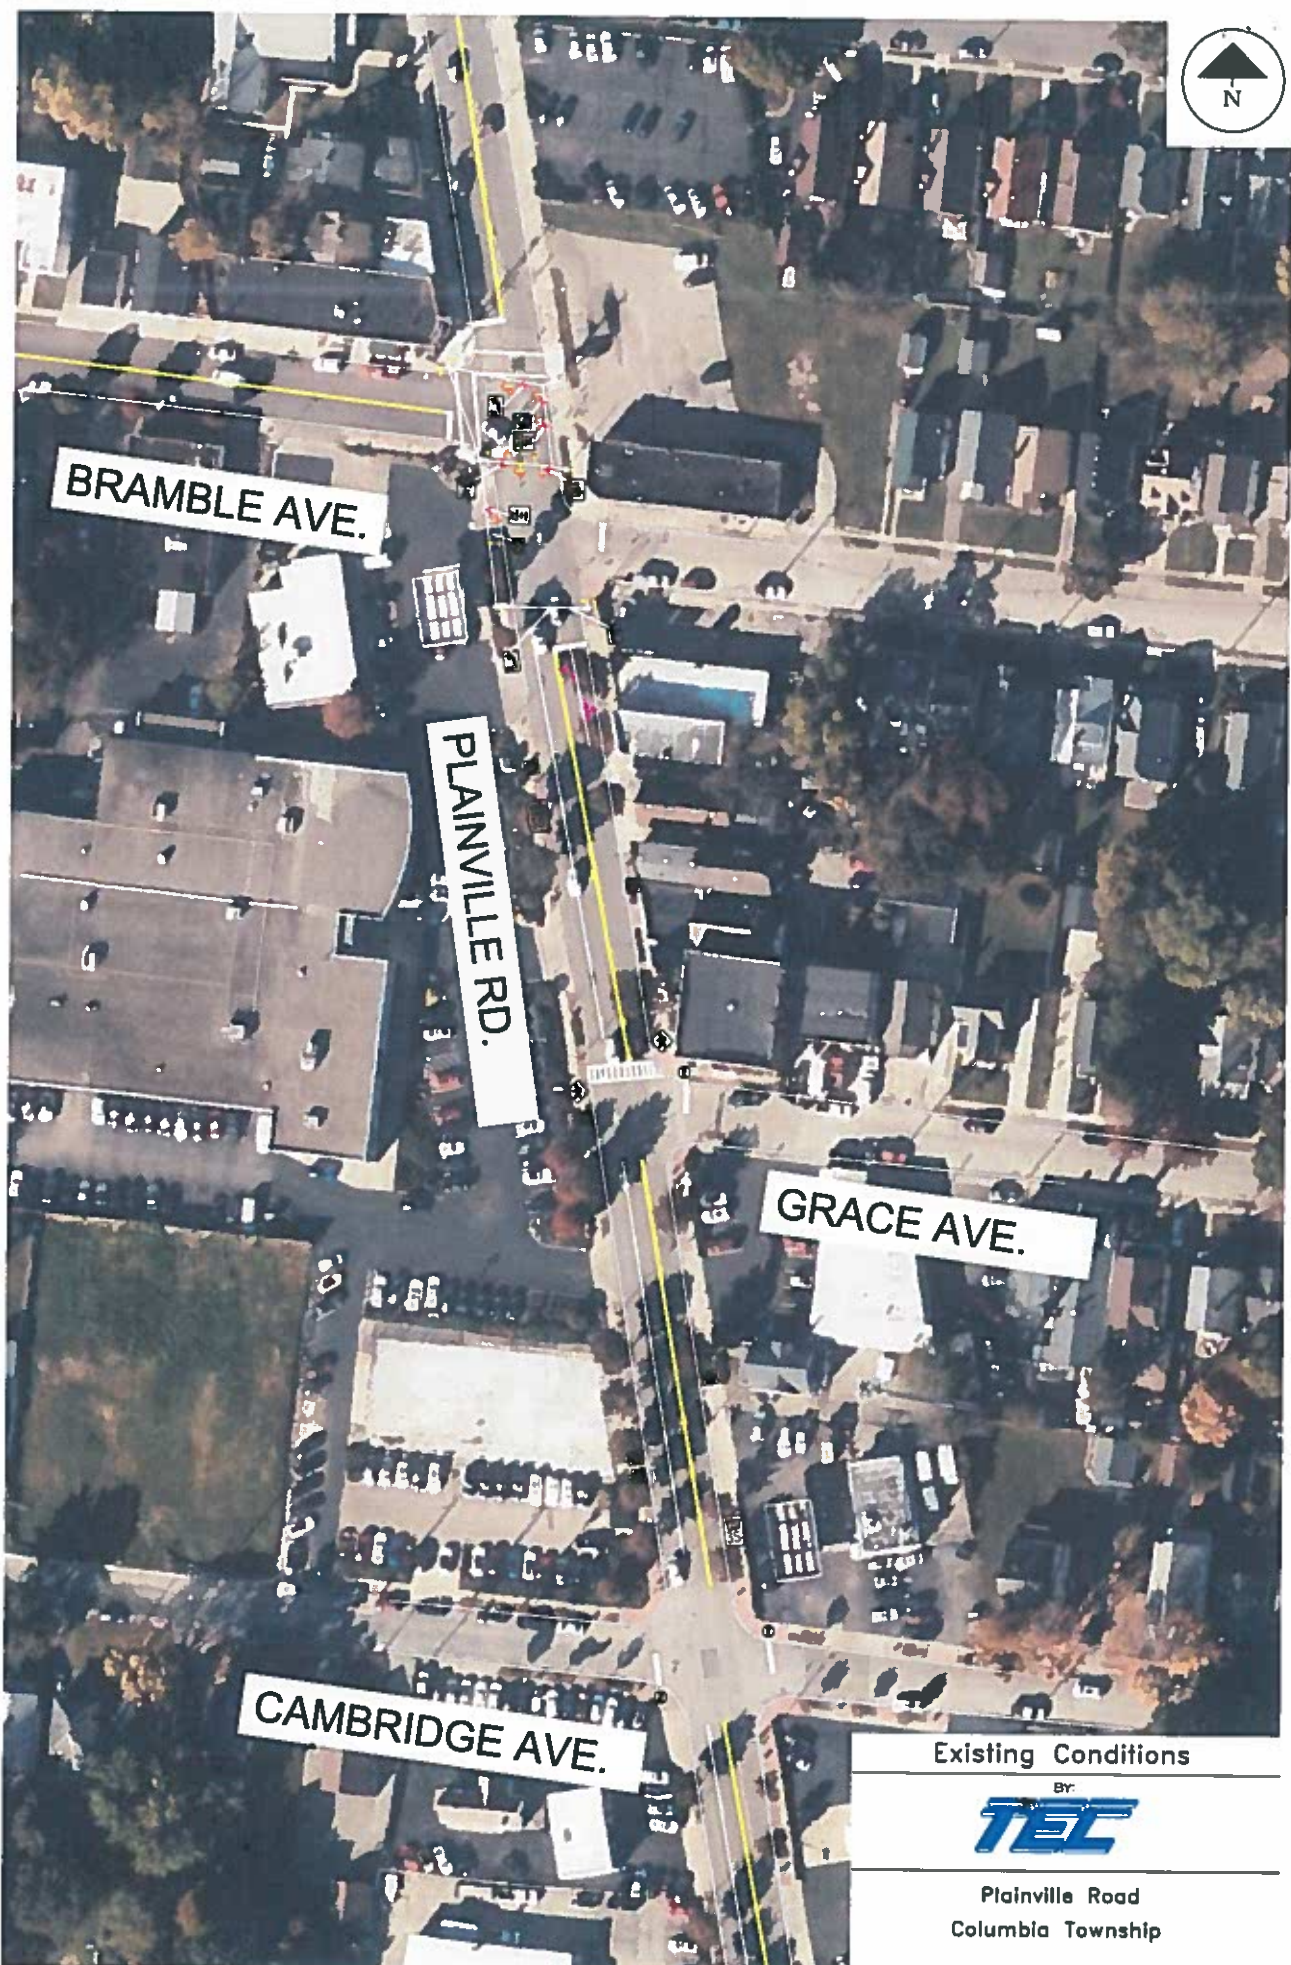
Existing Conditions

BRAMBLE AVE.

PLAINVILLE RD.

GRACE AVE.

CAMBRIDGE AVE.

Plainville Road  
Columbia Township

TEC determined there is adequate stopping sight distance at this location based on a speed of 35 mph. The crossing is at the crest of a small vertical curve, but this does not impede the sight line. While the crossing is less than 300' from a signalized intersection, the existing location of the crossing is the preferred location. Moving the crossing to the south side of the Grace Avenue intersection would make the crossing more difficult to see for southbound vehicles.
